## **APPENDIX L**

### Photographs

Appendix L. Photographs taken throughout the study watersheds. The first section of photographs include images captured at representative sites throughout the watersheds. The last section (L17-L22) includes photographs taken of culverts located downstream from discharge monitoring locations. These photographs were taken to help assess how similar (e.g., unobstructed) the culvert openings were prior to each monitoring event. Photographs were not collected prior to the first storm (3/28/00) because a camera was not available at the time (culverts were cleaned just before sampling/monitoring occurred).

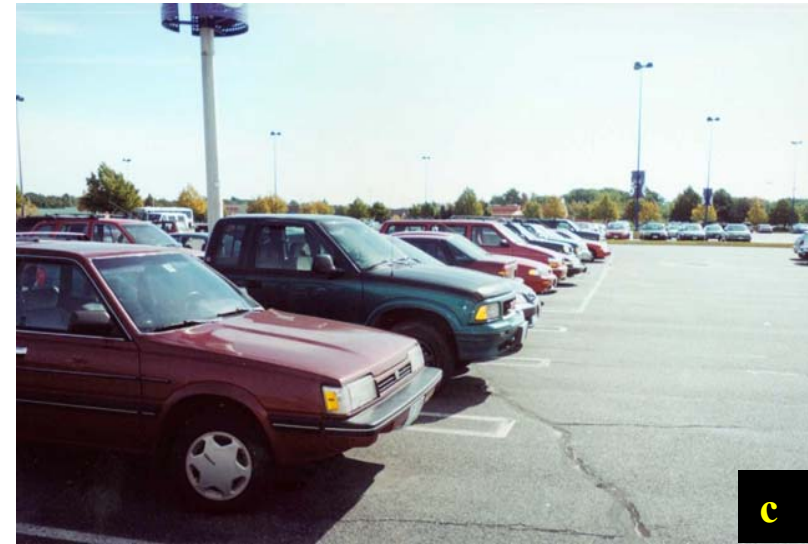
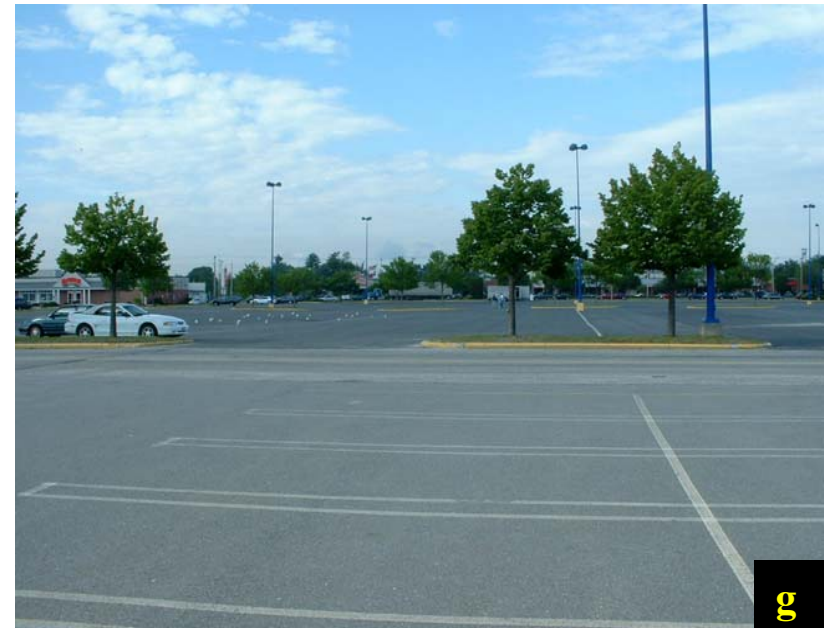
Appendix L-1. Photographs taken of various impervious surfaces and associated stormwater pollution problems: automobile-related petroleum pollution (a); antifreeze (b); parking lots and roads (c,d,e,g); and stormwater drain (f). Photographs taken between 2001 - 2002.

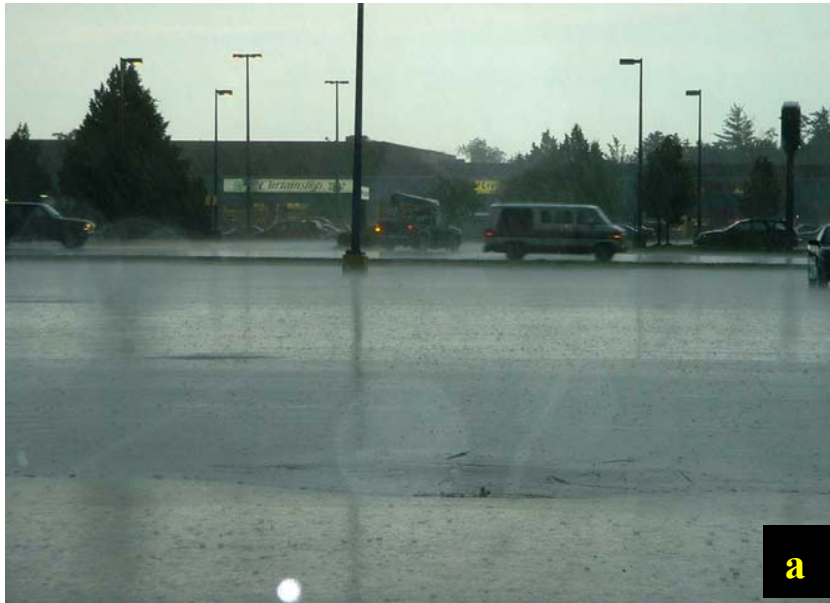
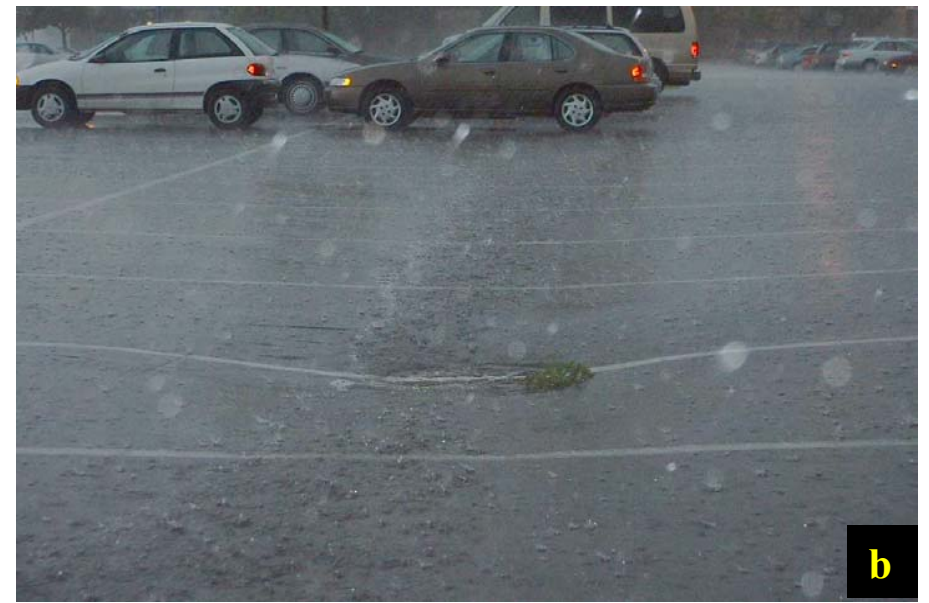
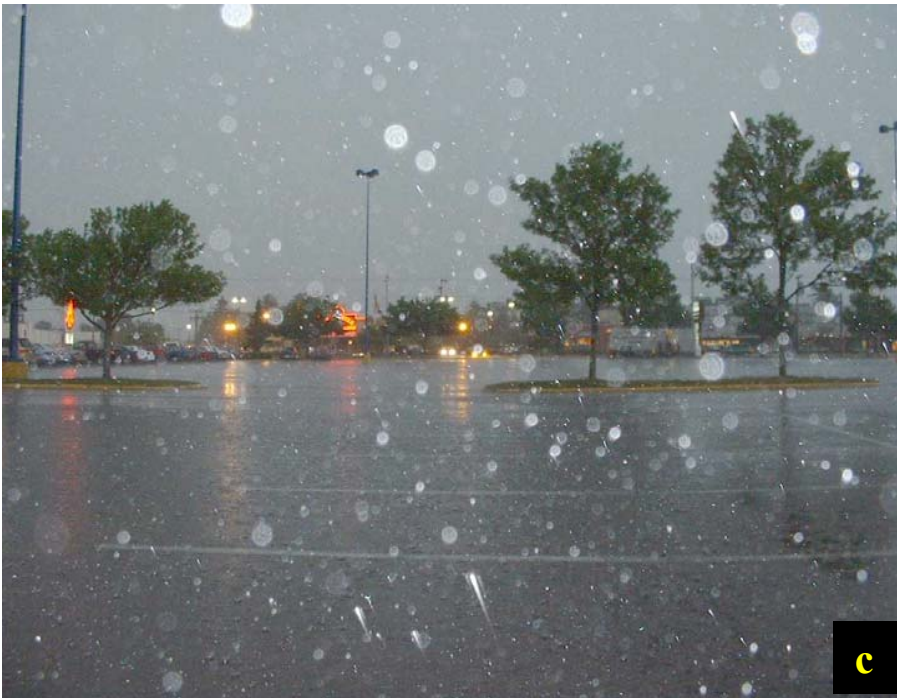
Appendix L-2. Photographs taken on 6/28/00 of impervious surfaces and stormwater runoff in the study watersheds.

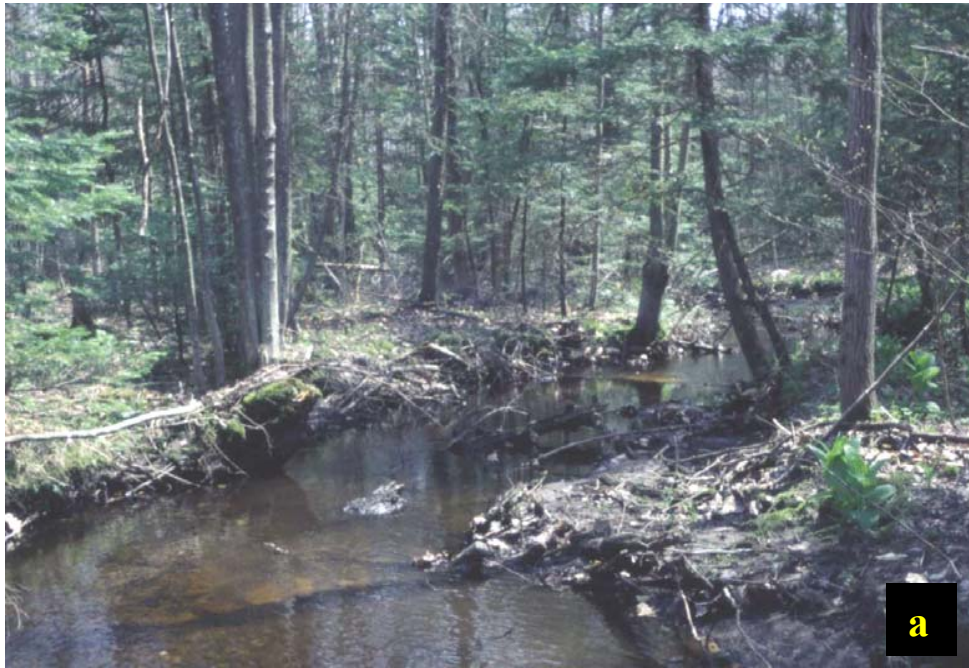
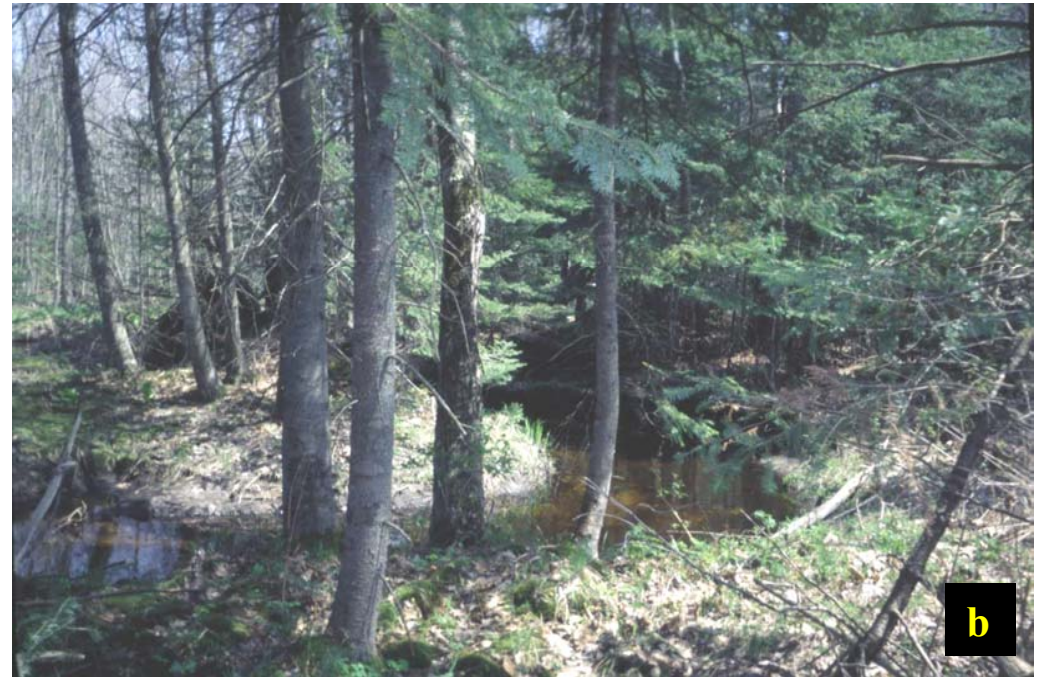
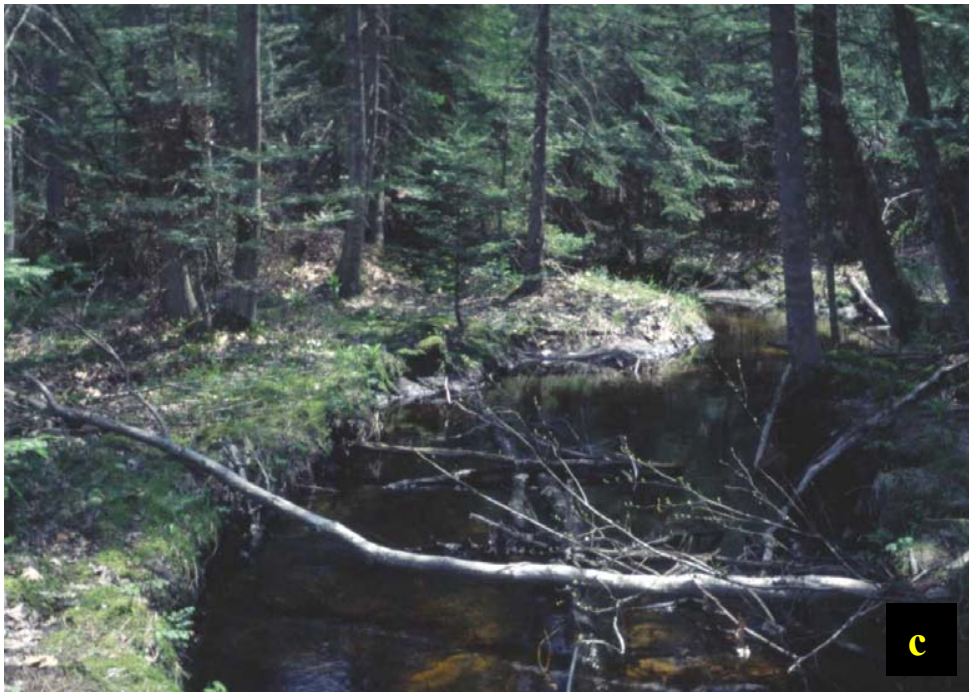
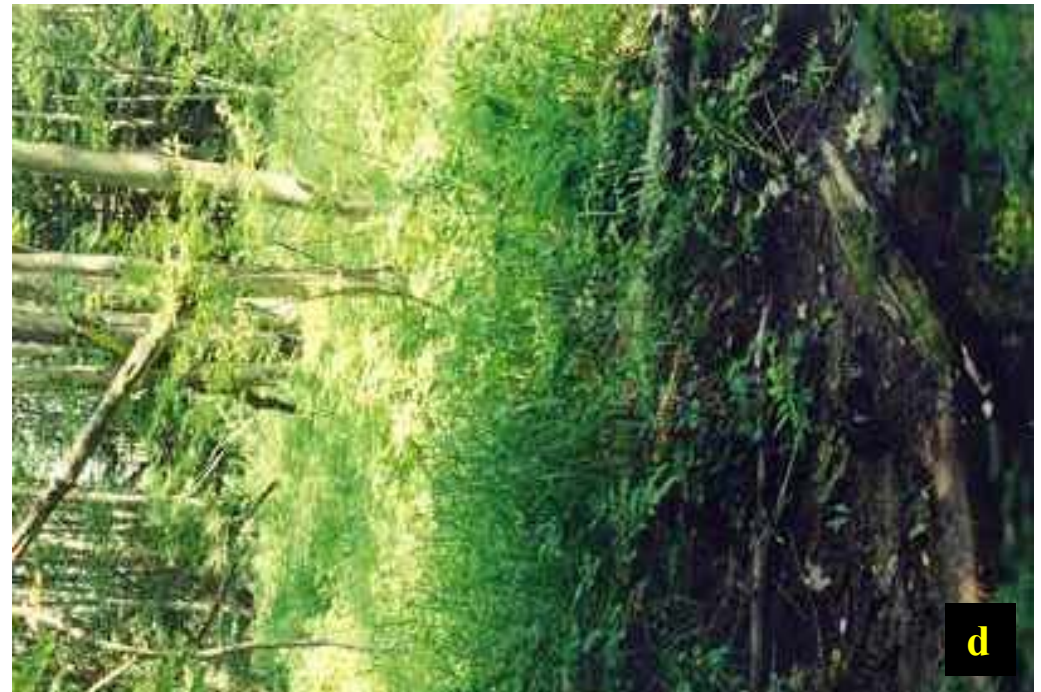
Appendix L-3. Photographs taken on 5/4/00 near RB-3.961 (a-c) and on 7/23/00 near RB-3.961 (d). Photograph “d” is oriented sideways.

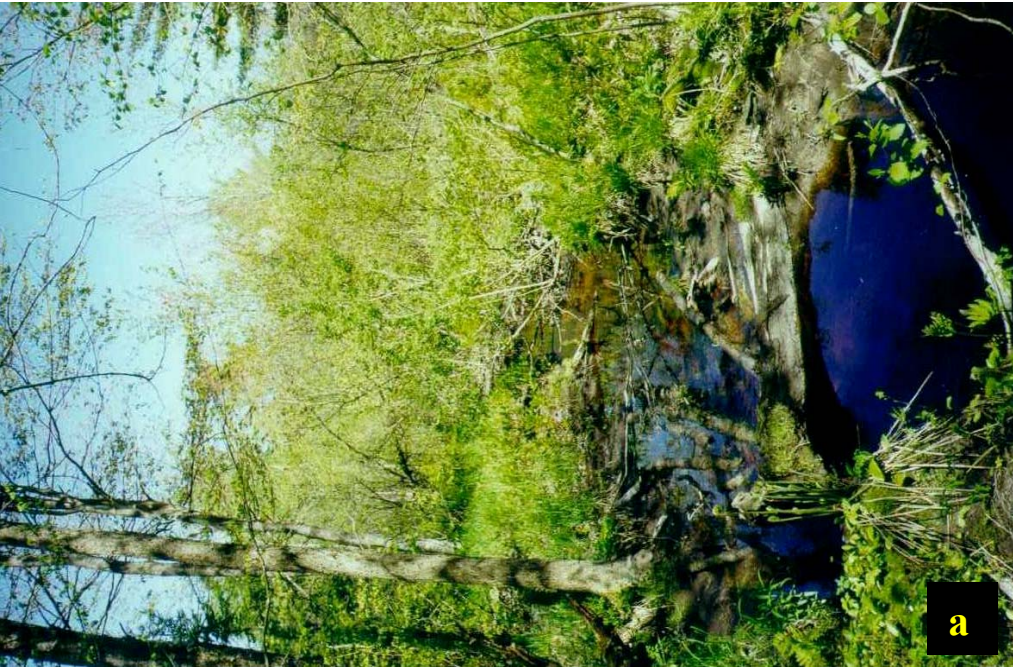
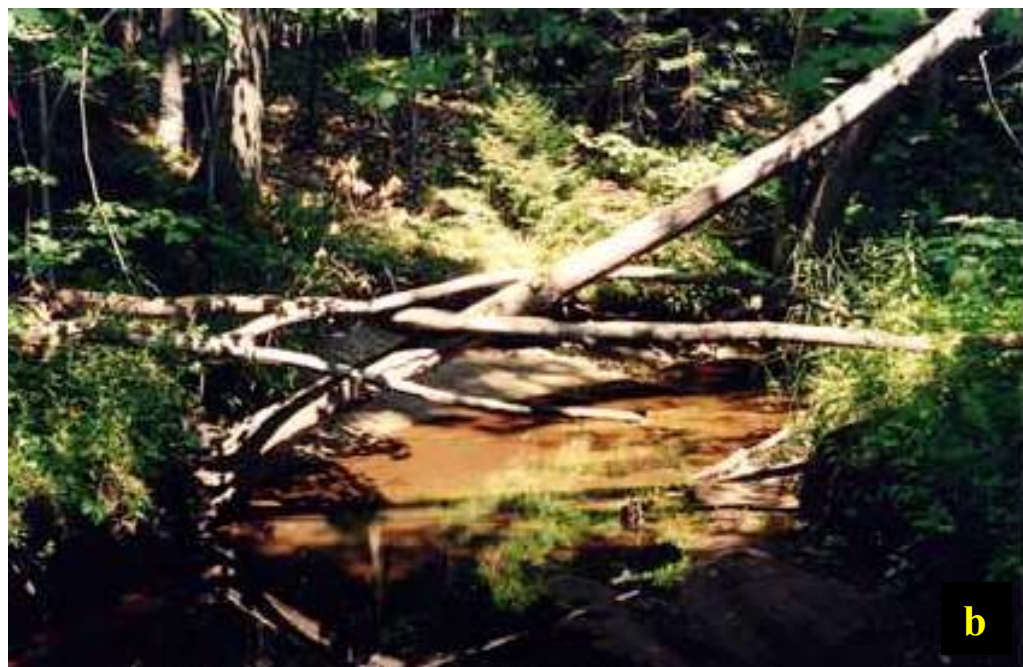
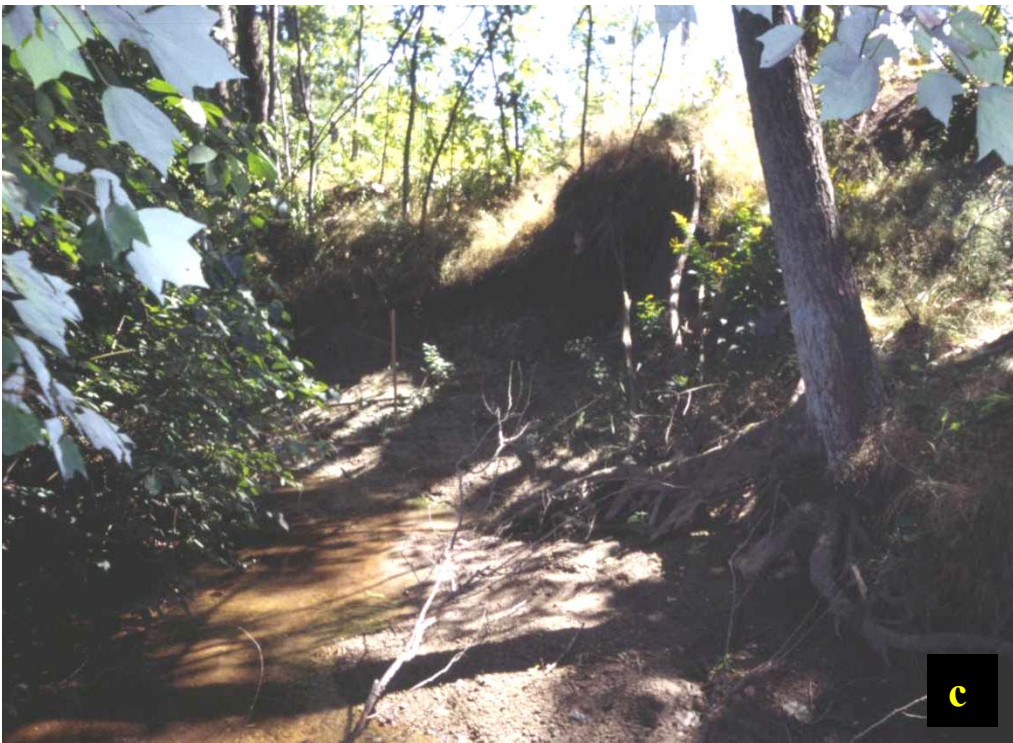
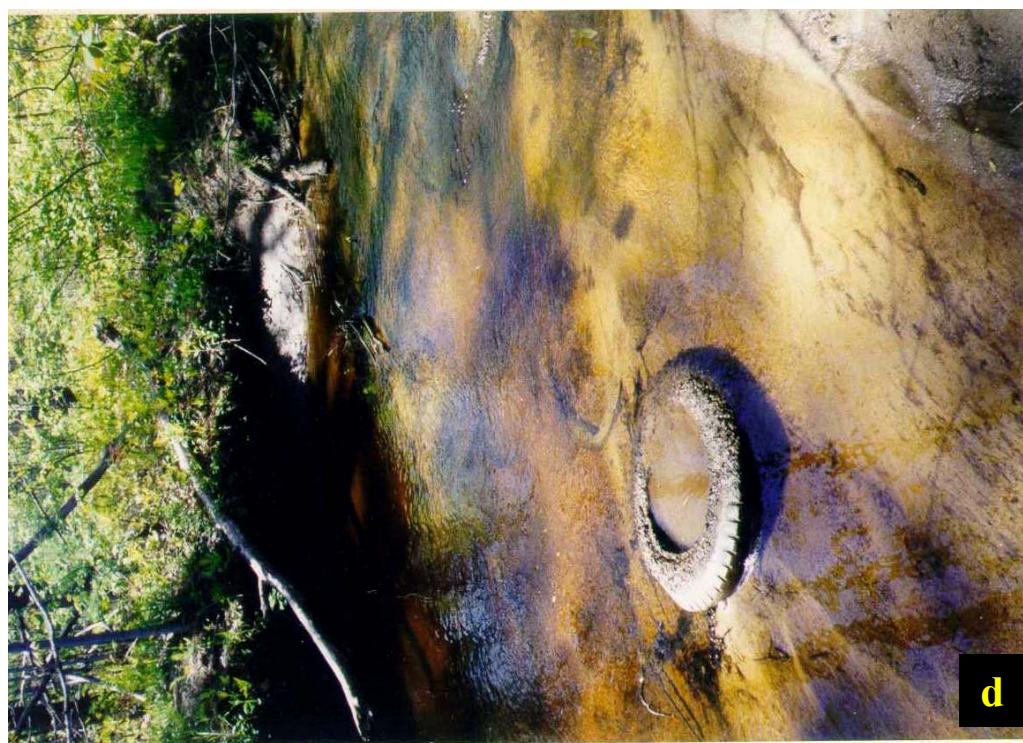
Appendix L-4. Photographs taken on 5/13/99 near RB-2.5~ (a) and on 7/23/01 (b) and 5/13/99 (c-d) near RB-1.45~. Photographs “a” and “d” are oriented sideways.

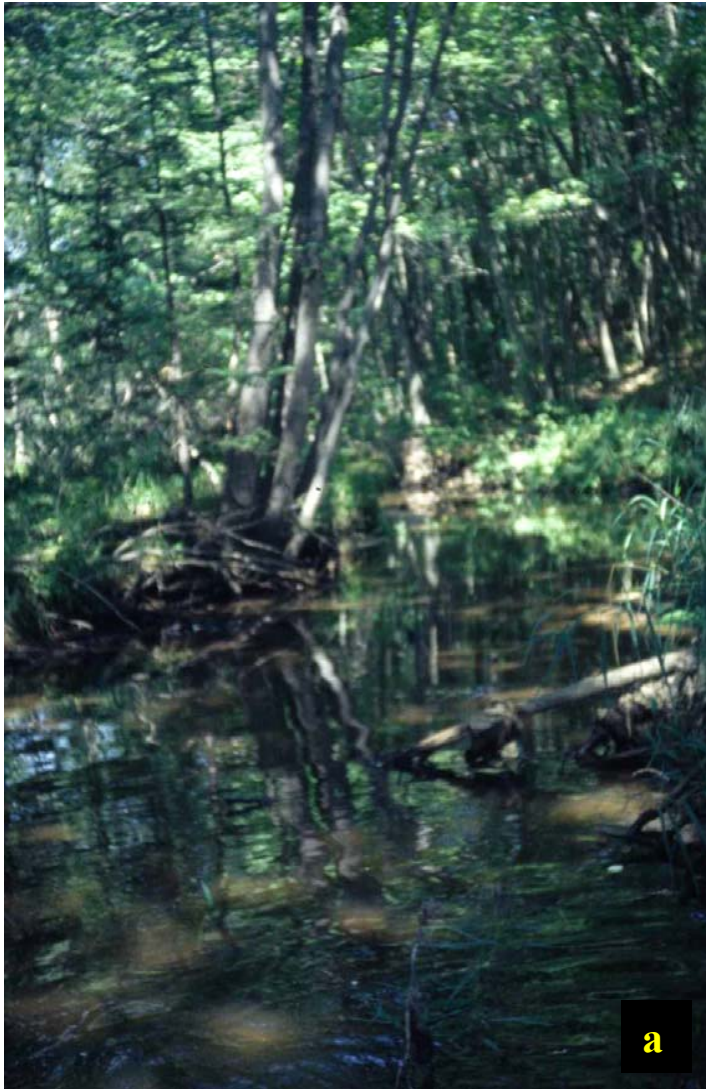
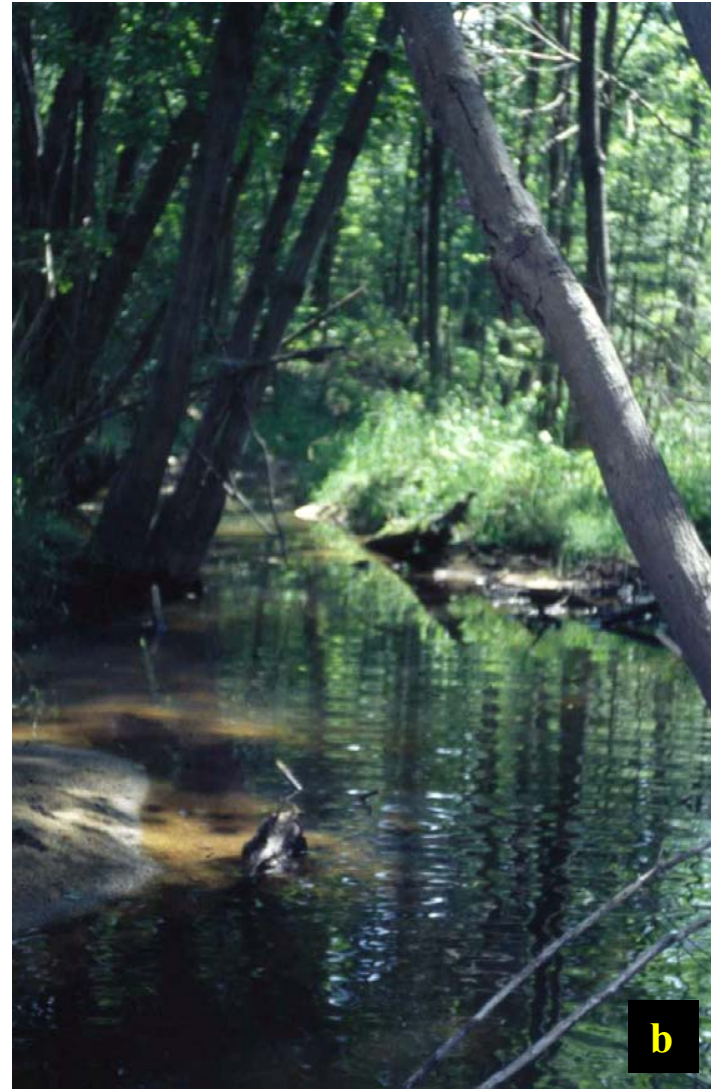
Appendix L-5. Photographs taken on 5/13/99 near RB-0.071.

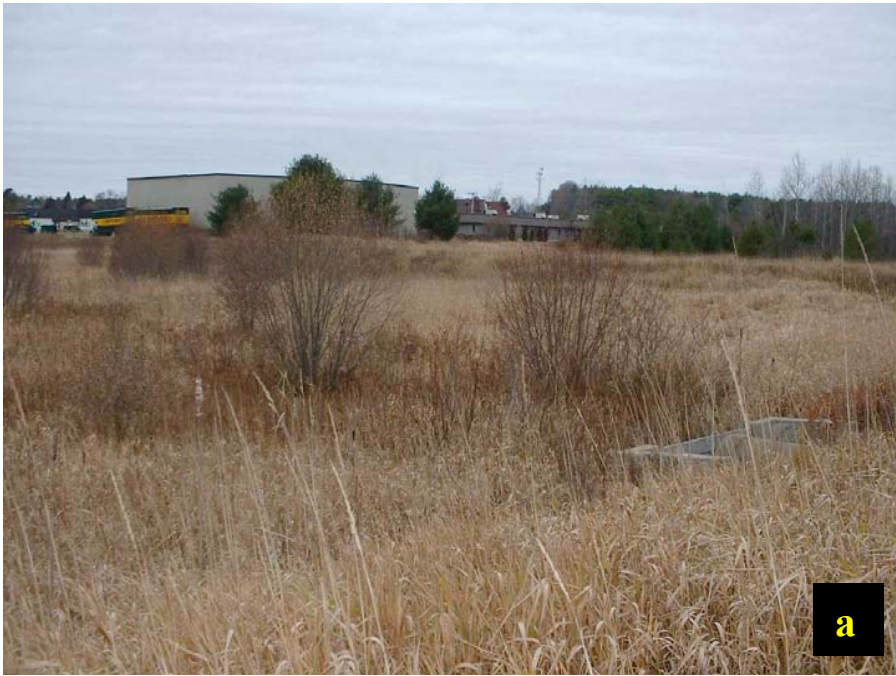
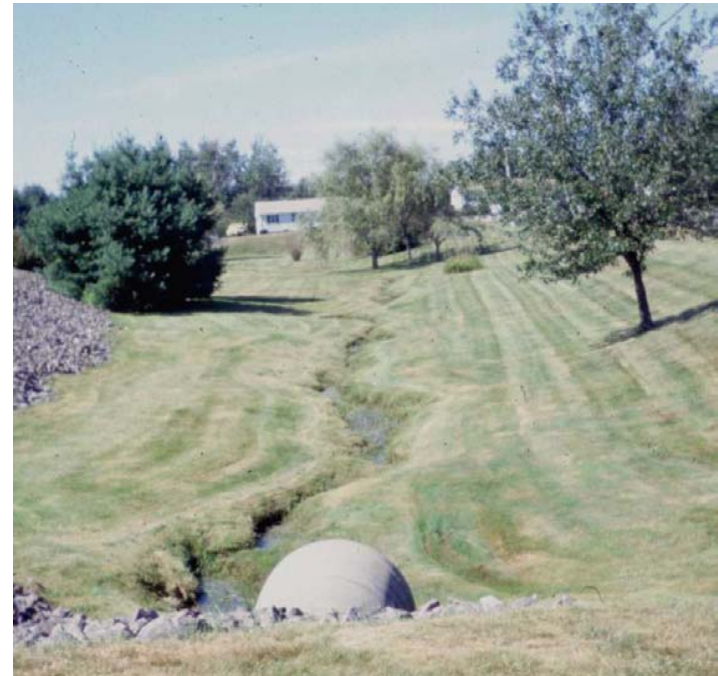
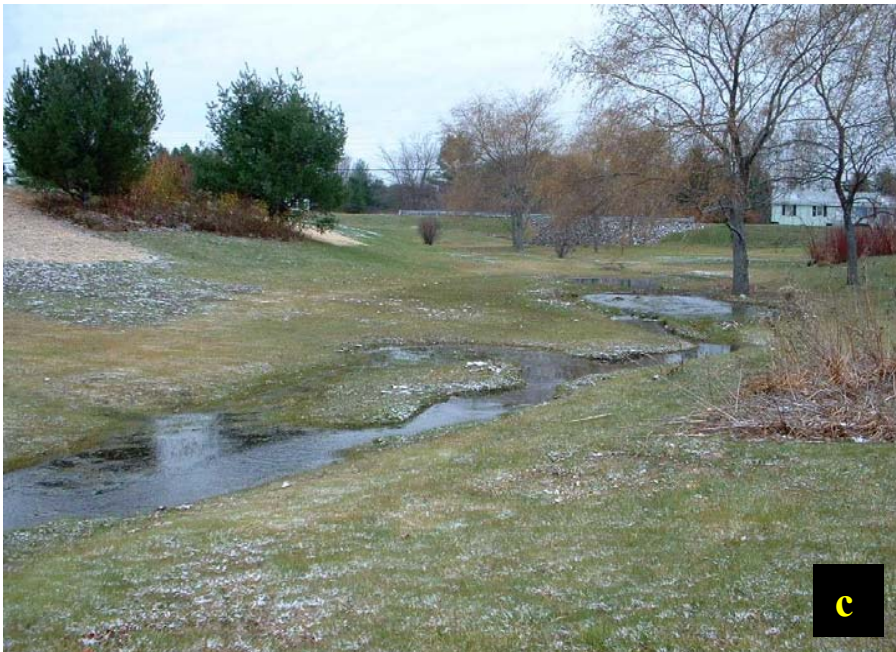
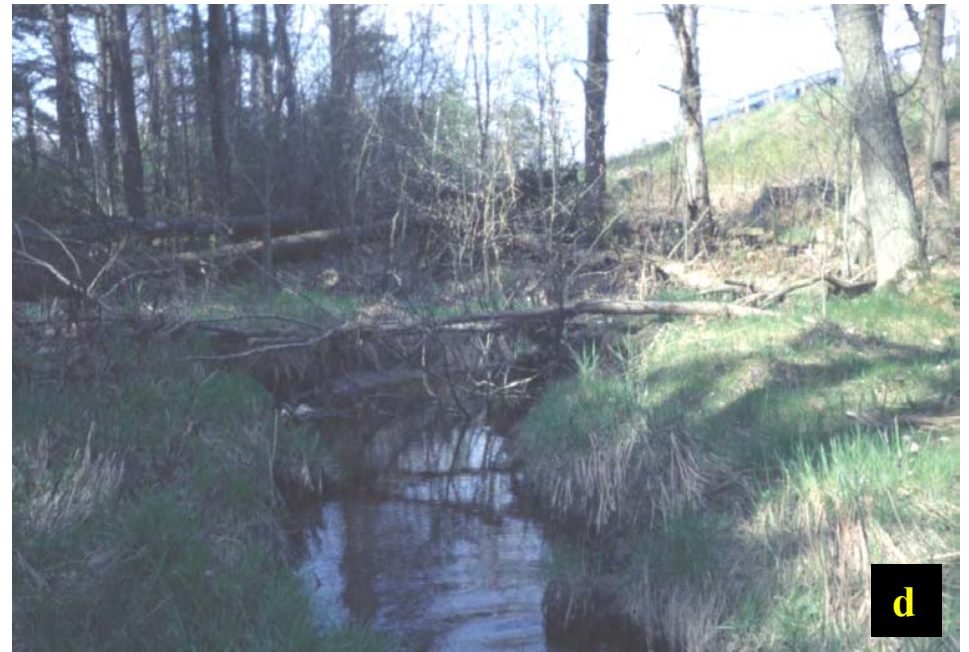
Appendix L-6. Photographs taken of: an in-stream detention basin near LC-Mn-2.85 (a); a section lacking an intact riparian zone near LC-M-2.65 (b,c); and a channelized section near LC-M-3.0. Dates: 11/16/02 (a,c) 7/12/00 (b); and 5/4/00 (d).

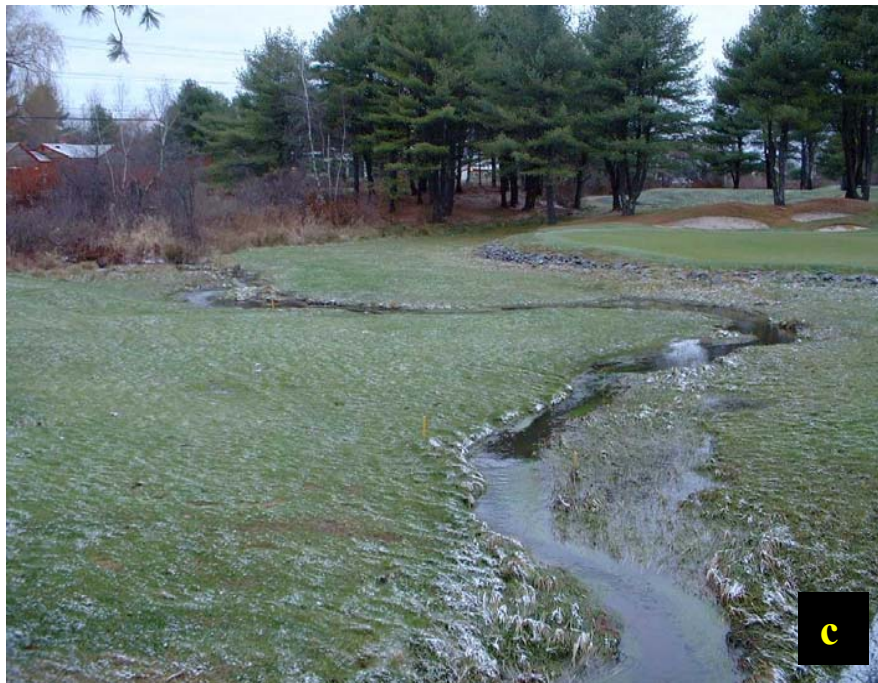
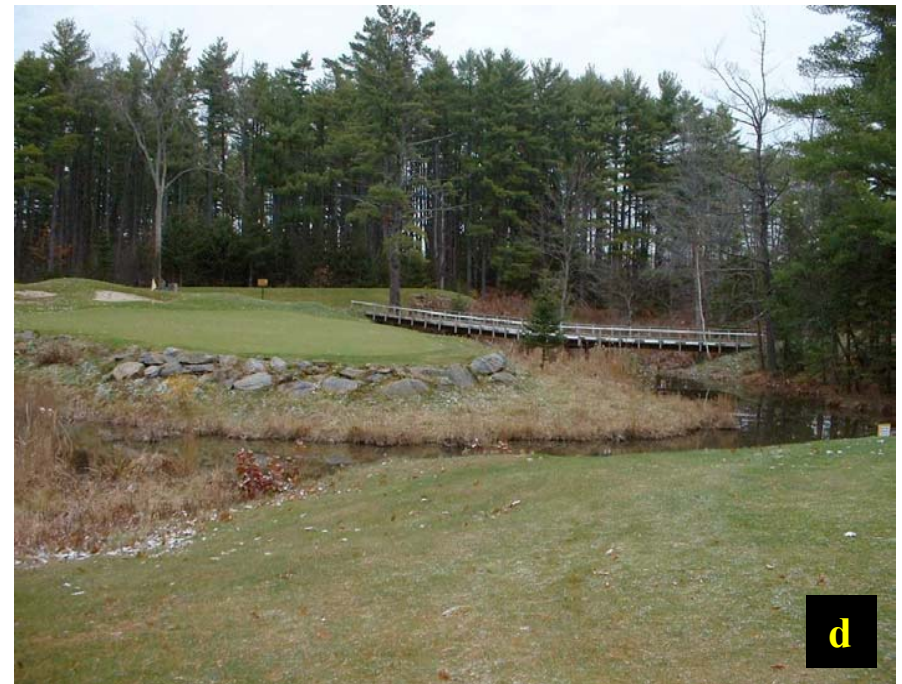
Appendix L-7. Photographs taken of an in-stream detention basin, dam, and concrete outfall (a), taken on 5/13/02, and portions of LC-M flowing through a golf course between stream mile LC-M-2.3~ and 2.7~ (b-d), taken on 11/16/02.

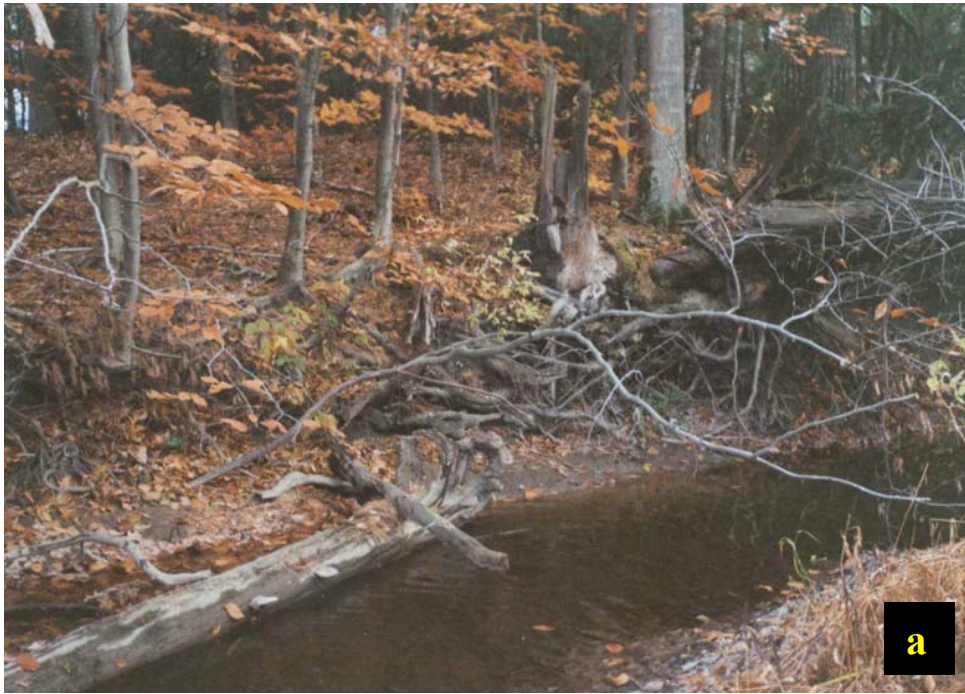
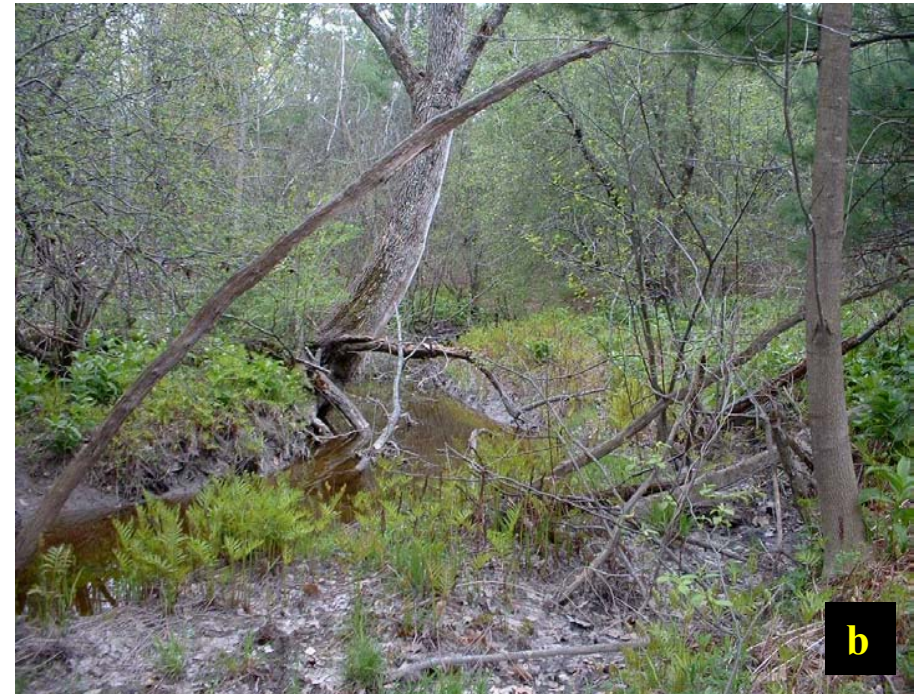
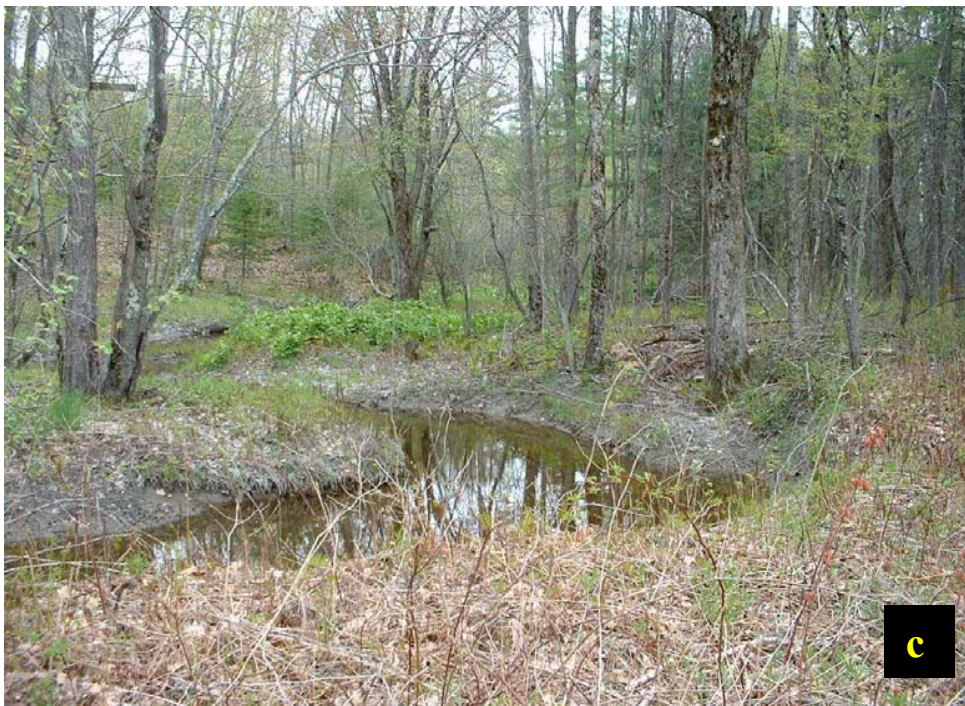
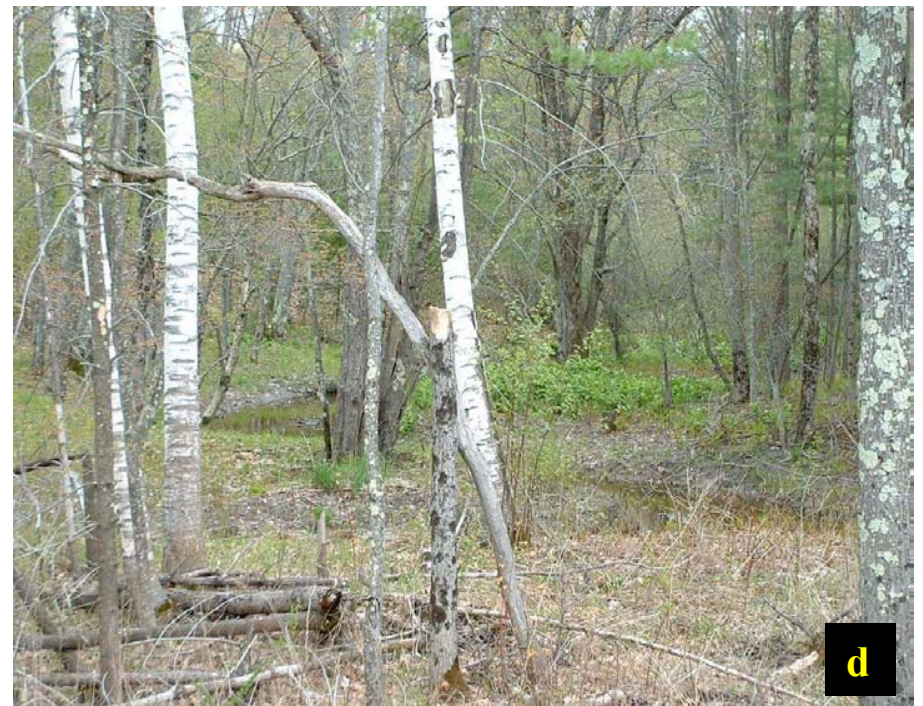
Appendix L-8. Photographs taken near LC-M-1.4 to 1.6 where riparian zone vegetation and floodplains have remained fairly intact. Note, however, what appears to be signs of stress from increased stormwater volumes due to development of the upper watershed (a). Dates: 10/24/00 (a) and 5/13/00 (b-d).

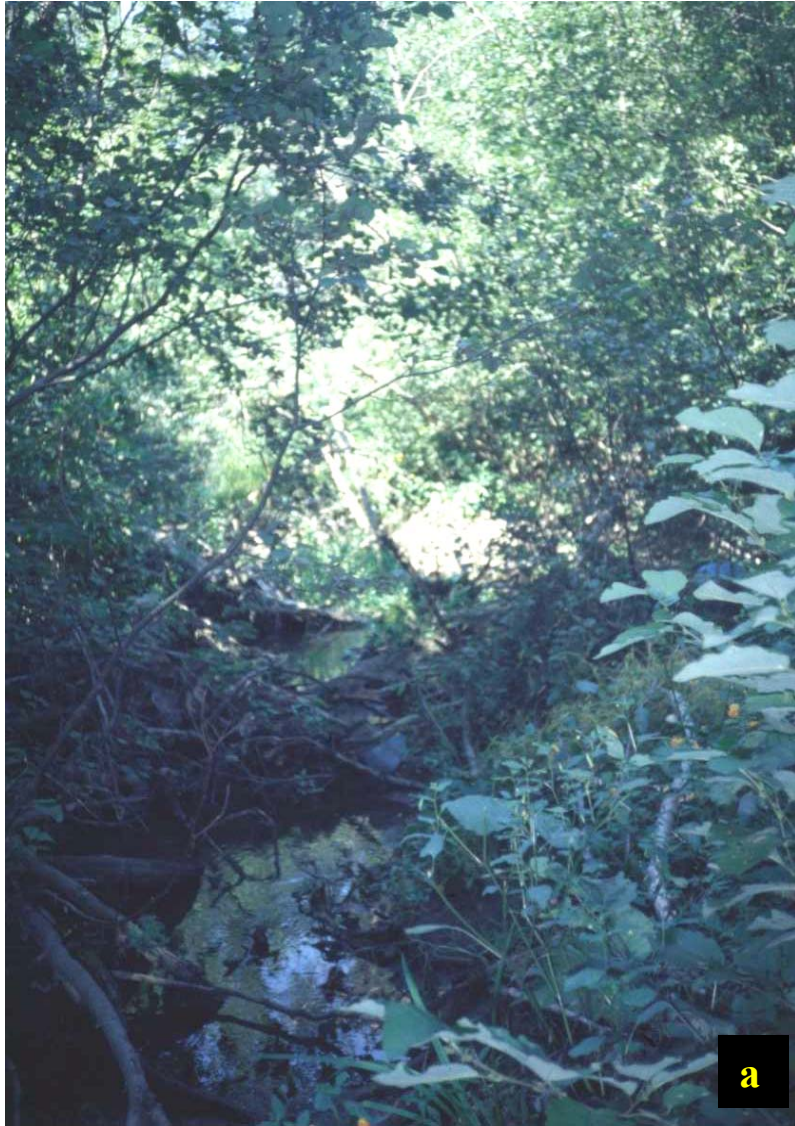
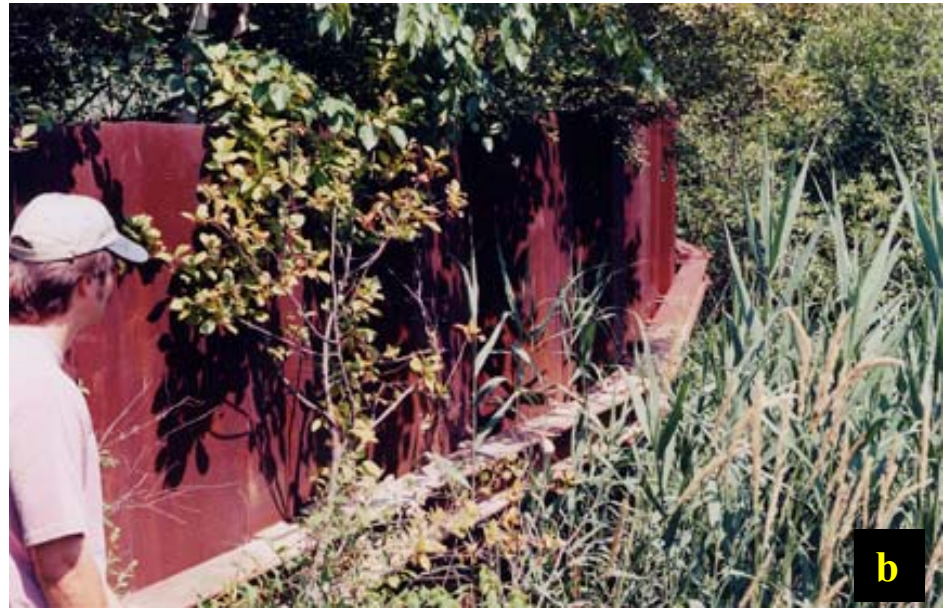
Appendix L-9. Photographs taken near LC-M-0.9~ of: a shaded section of stream (a), a stormwater detention pond and its outfall pipe (b-c), and a detention basin outfall pipe near LC-M-0.65~ (d). Date: 6/12/99 (a), 7/23/01 (b-c), and 11/10/00 (d).

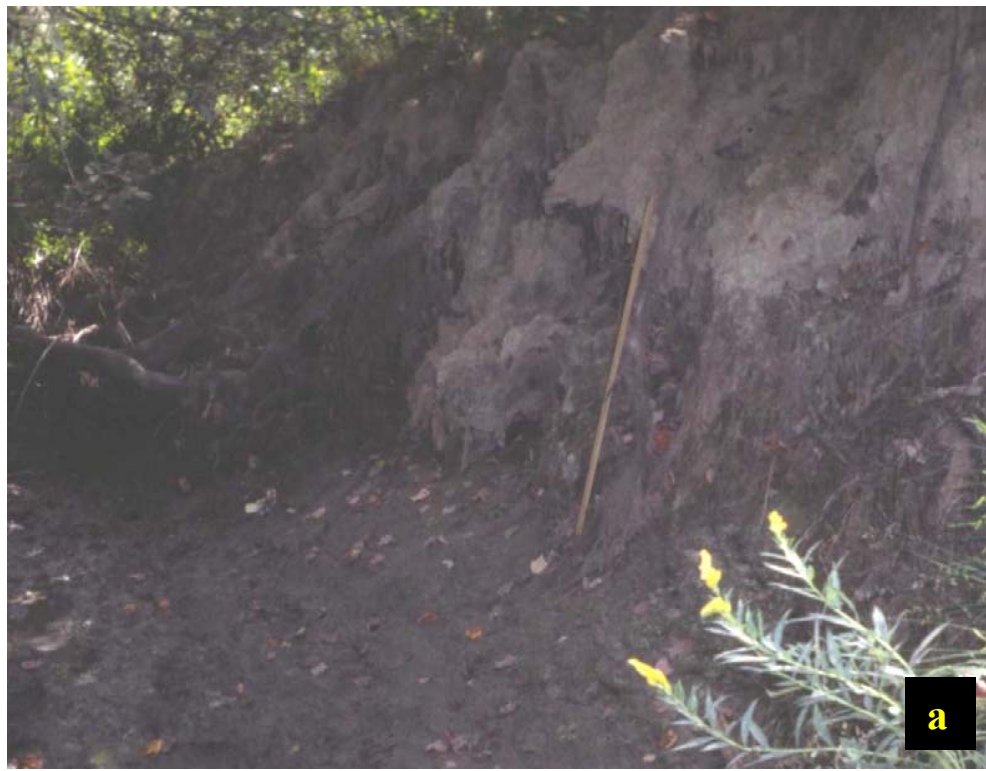
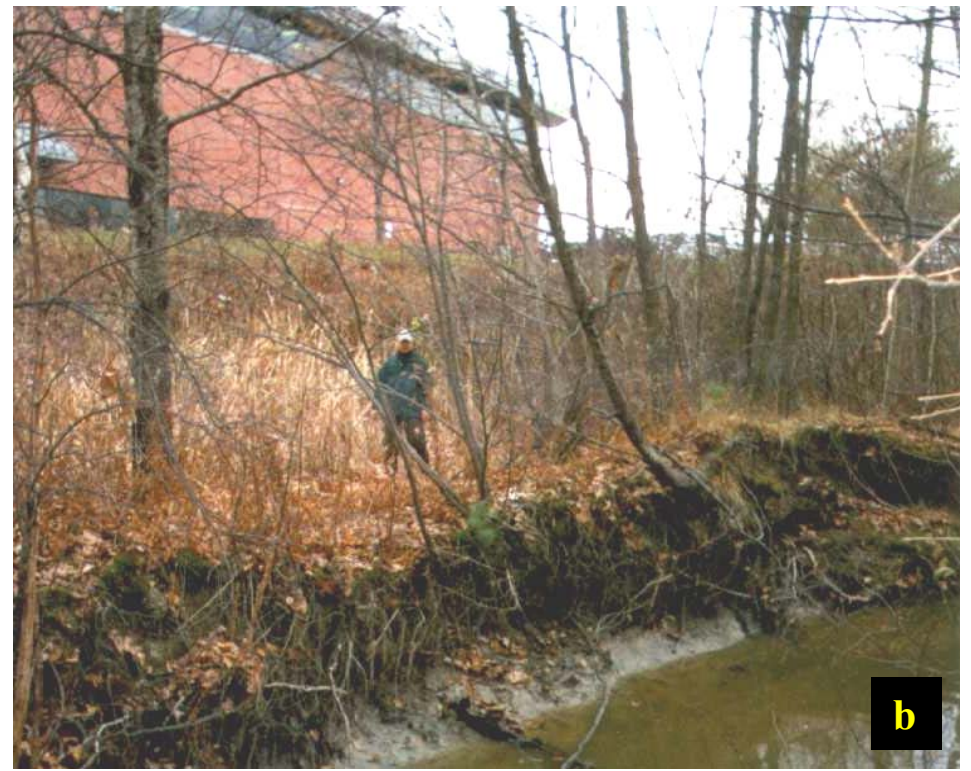
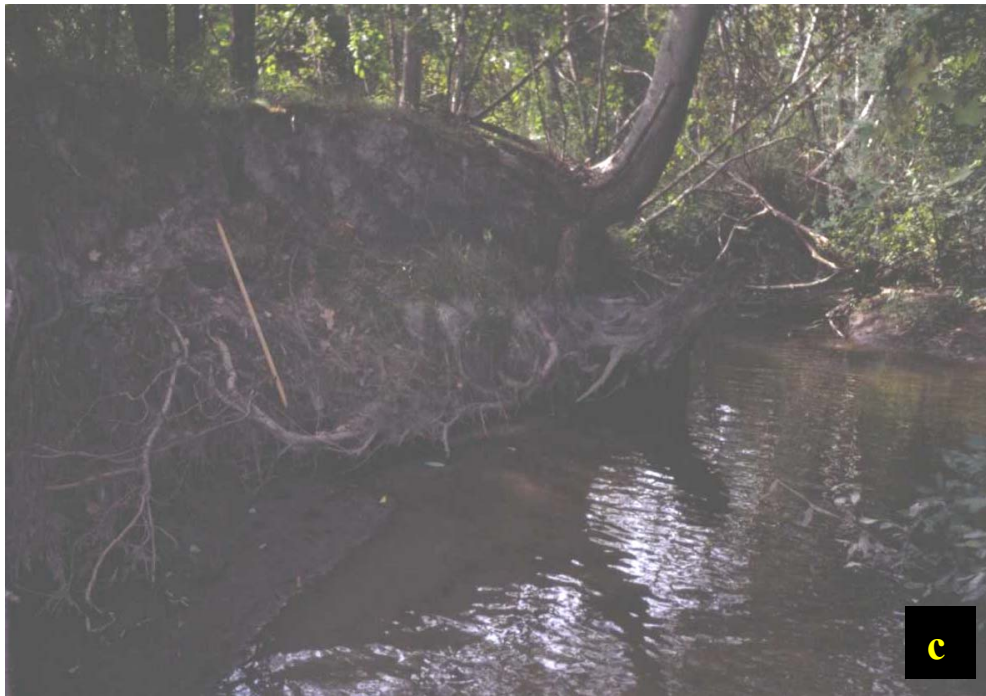
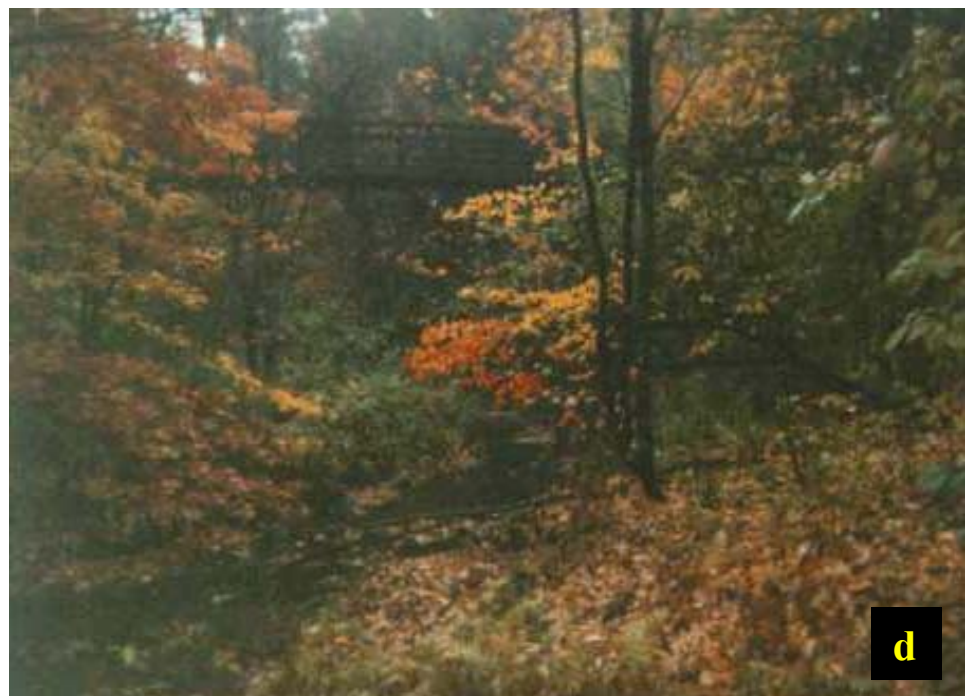
Appendix L-10. Photographs of severe streambank erosion and channel overwidening near LC-M-0.6~ (a-c) and a bridge over the stream (d). Dates: 7/13/00 (a,c), 12/1/00 (b), and 10/18/00 (d). Note the 1-m long measuring stick in photos a and c for scale.
